DEMONSTRATION OF A NON-AQUEOUS SEWAGE DISPOSAL SYSTEM

Black Hills Conservancy Sub-District
Rapid City, South Dakota

December 1973

15. Supplementary Notes
Environmental Protection Agency, report ~~number~~, Technology Series EPA-670/2-73-088, December 1973. 131 p, 7 fig, 20 tab, 2 ref

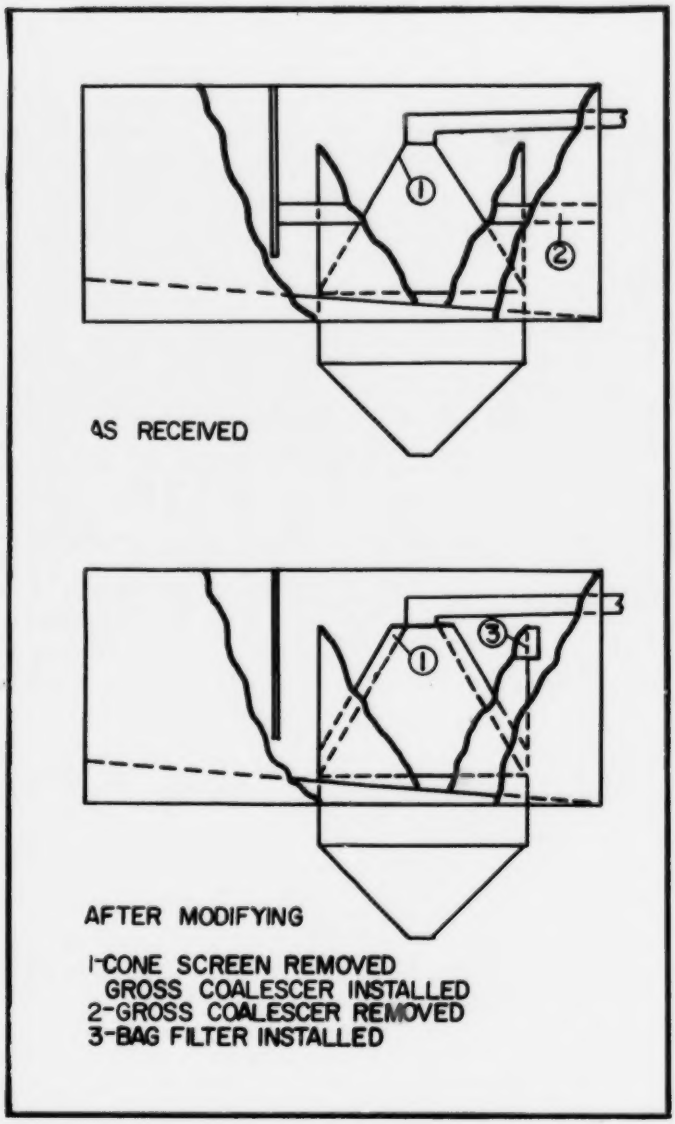
Figure 3. Aqua-Sans Reservoir
Sectional View Showing Modifications (Not to Scale)

Initially the oil, prior to overflowing into the storage reservoir, was passed through a cone screen for preventing large solids carryover. The oil was then passed through a horsehair-fiberglass gross coalescer (which was placed horizontally in the reservoir) for removing water from the oil. During the demonstration period (see Section VIII, Reservoir and Waste Sump), the cone screen was replaced with a cone-shaped horsehair-fiberglass coalescer. A bag filter was also installed at the top of the sump, and the horsehair-fiberglass gross coalescer removed. Figure 3 shows a sectional view of the reservoir and the modifications which were performed.

A brown, flocculent residue of finely divided particulate matter began to accumulate in the oil reservoir after two weeks of operation. The residue also collected on the cone screen in the waste sump and on the horizontal gross coalescer. Turbulence at the entrance to the waste sump was the primary cause of this waste carryover. In addition, operation of the recirculation pump and the sensor flush contributed to this problem. The cone screen and the gross coalescer were removed May 14, 1972, and a smaller coalescer was installed in place of the cone screen. Removal of the gross coalescer eliminated a large collection area for the waste; however, the internal cross braces and the inadequately sloped reservoir bottom continued to provide collection surfaces and traps for the particulate matter.

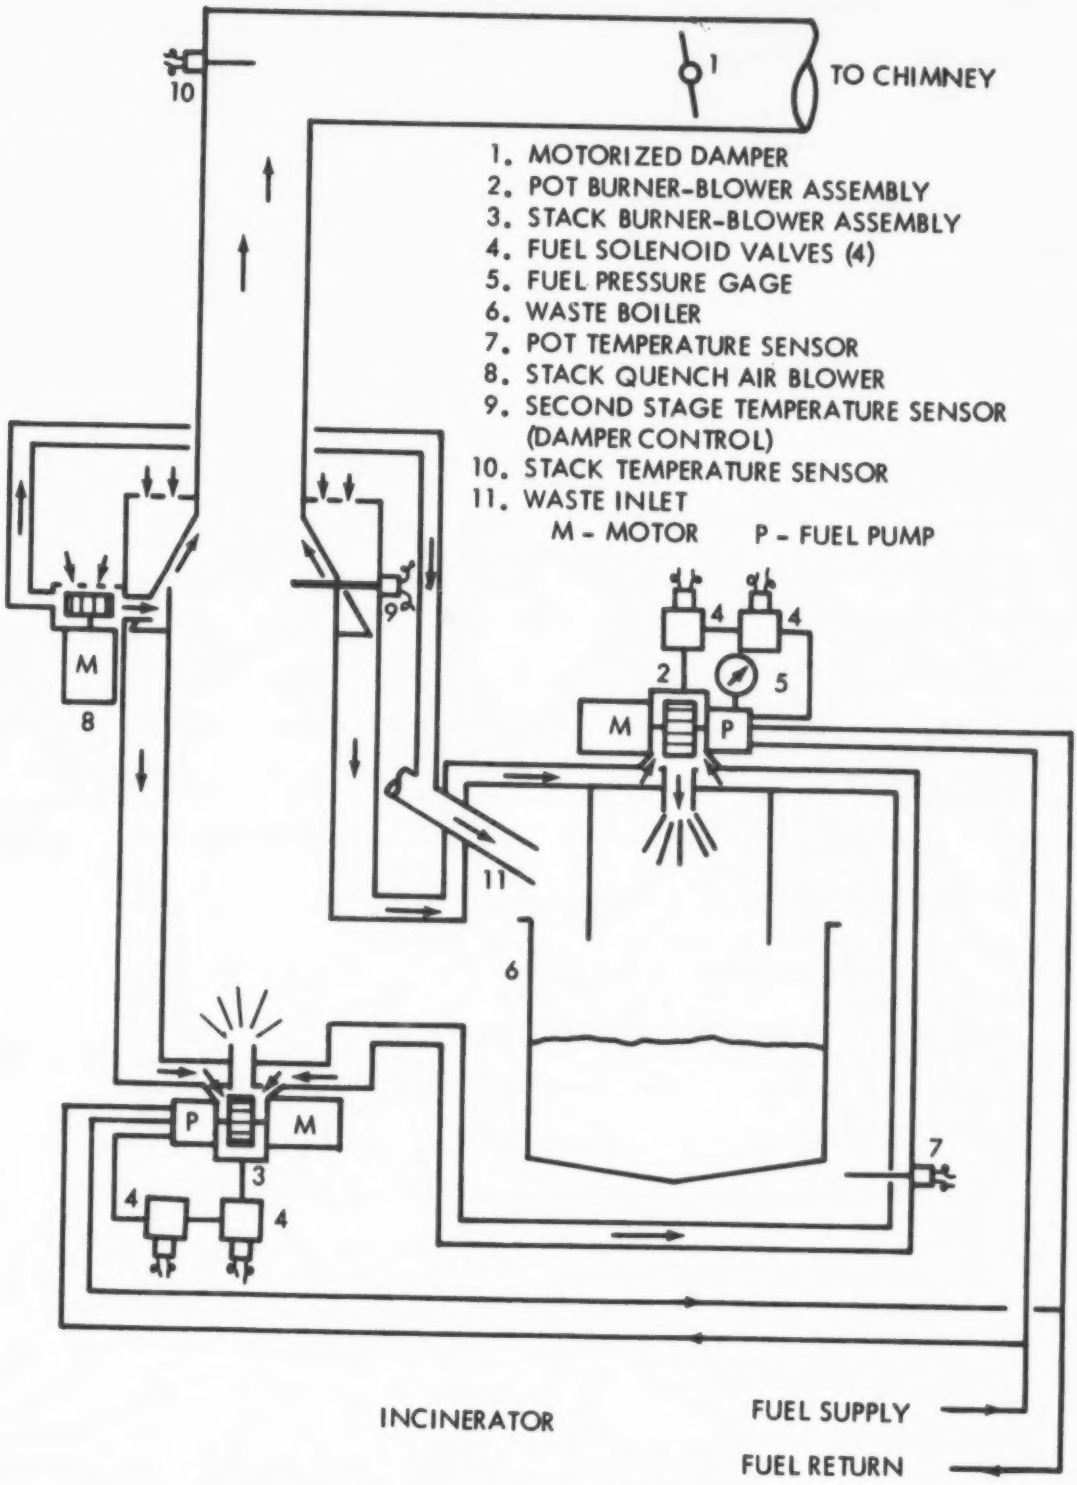
Figure 11. Incinerator System Mechanical Schematic

A 2-stage, oil burning incinerator (figure 11) fabricated of type 309 stainless steel, was designed for the system The first stage contains a crucible into which approximately 10 gallons of waste can be transferred. Exhaust gases are passed into a second stage where they are maintained at 1100 to 1300°F for sufficient time to ensure complete oxidation of exhaust products. Both stages are insulated with ceramic fibre insulation and are air cooled.
